Prepared by  
The Oldsmar Downtown Redevelopment Advisory Committee  
May 20, 1993

**FINDING OF NECESSITY**  
**Documentation of Conditions of Blight**  
**for the**  
**Proposed Oldsmar Community Redevelopment Area**

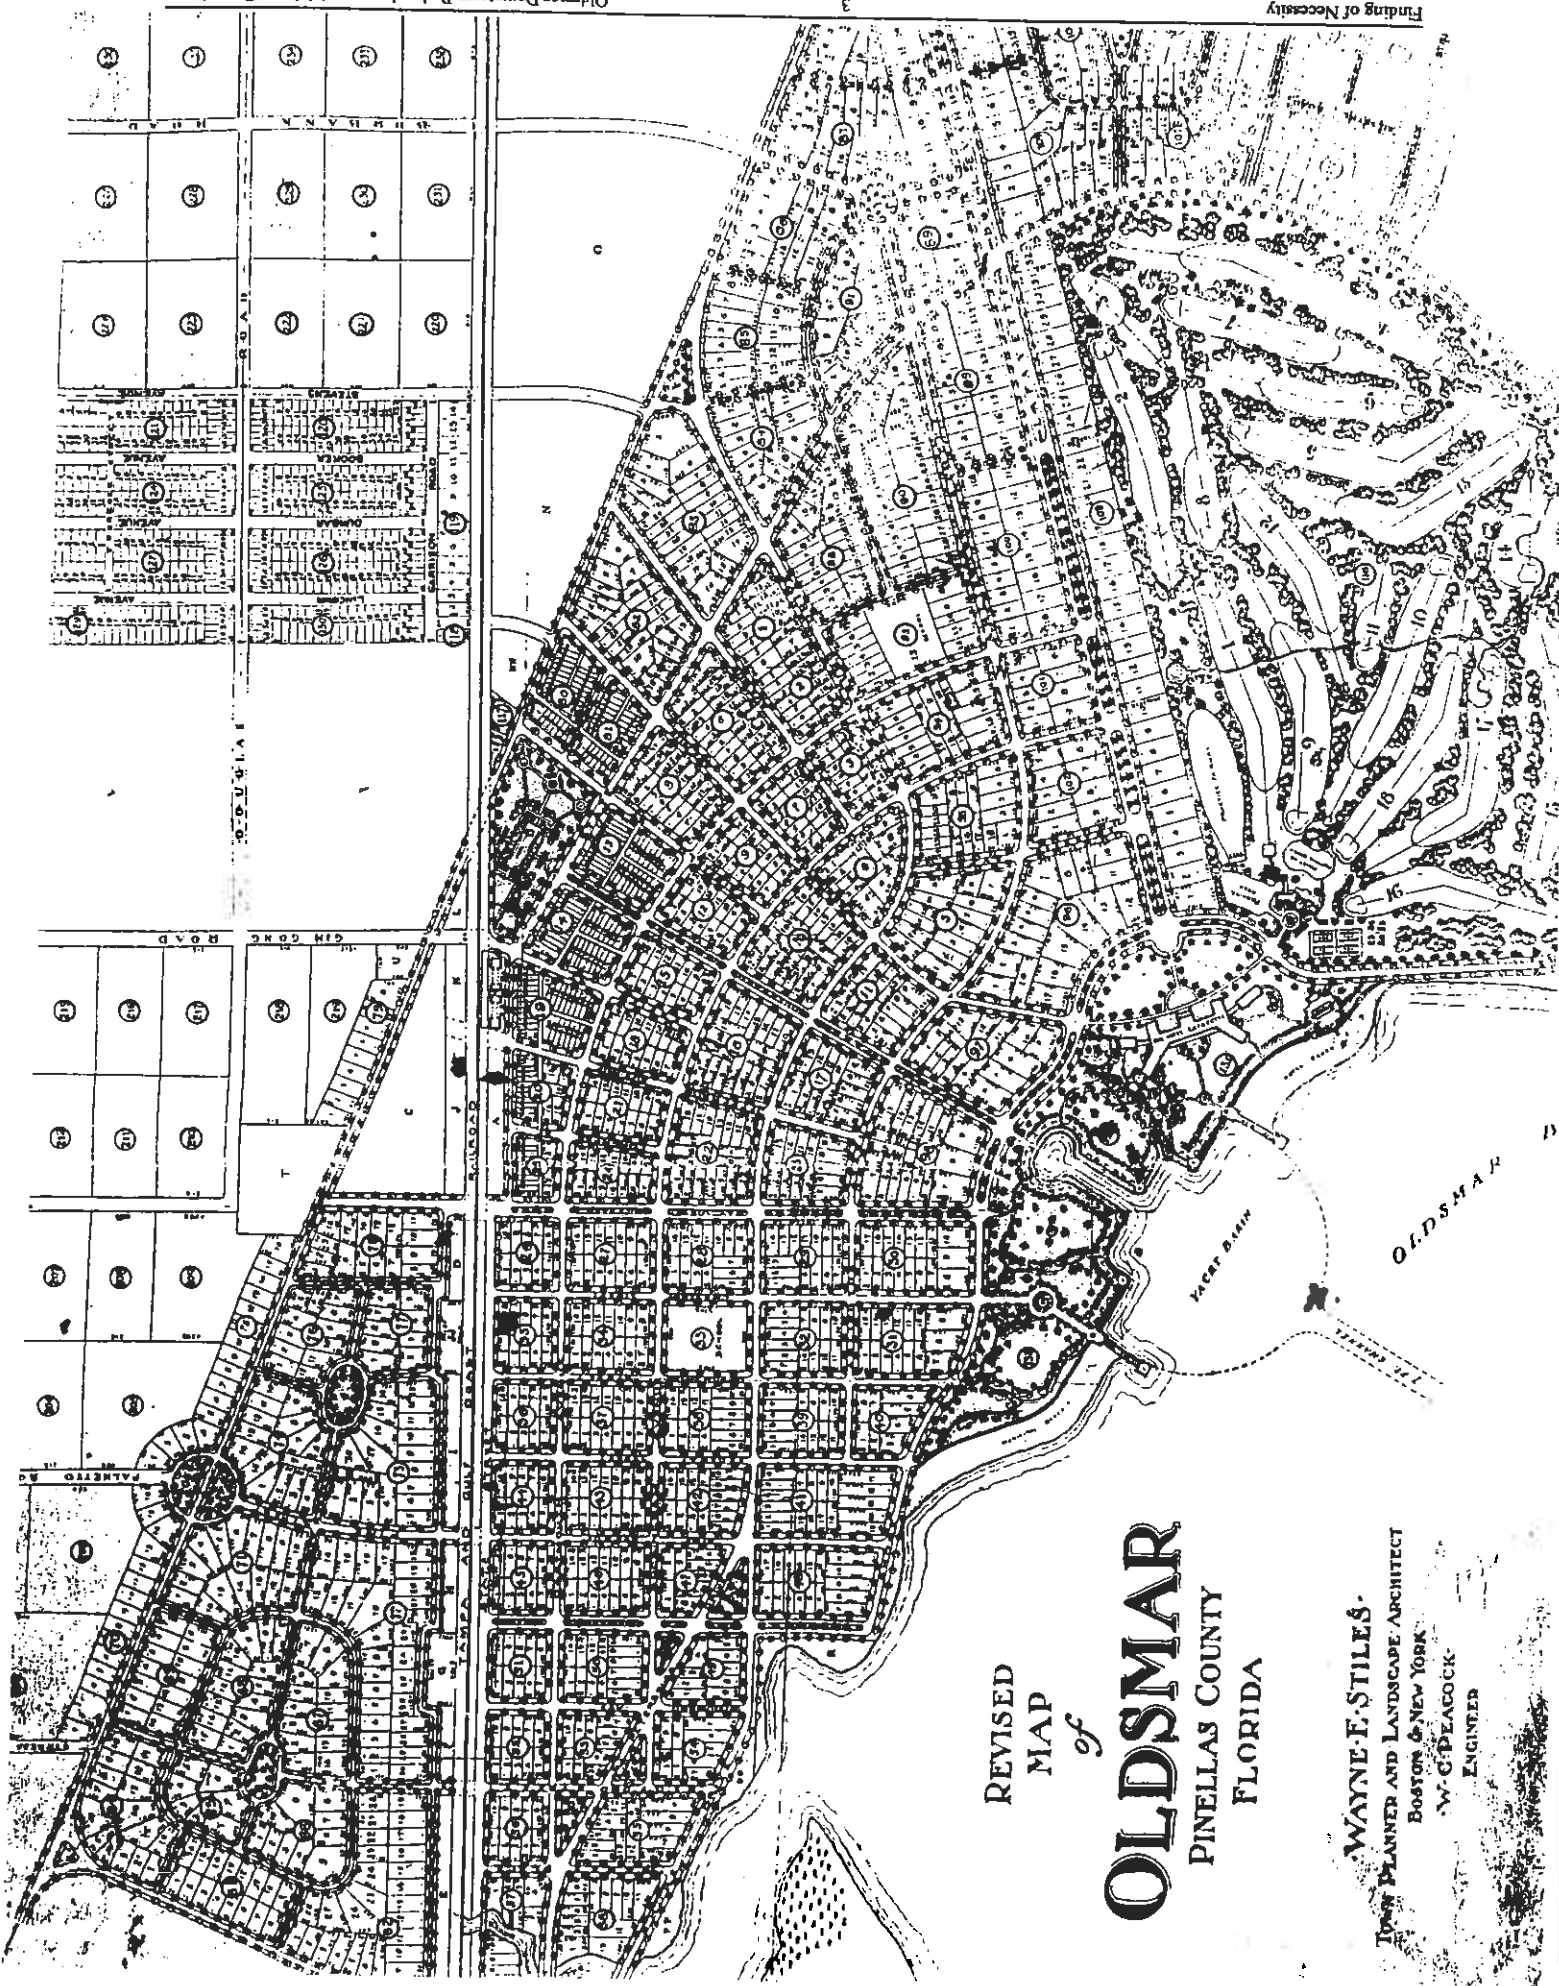
REVISED  
MAP  
of  
**OLDSMAR**  
PINELLAS COUNTY  
FLORIDA

This is especially true in city blocks along parts of State Street, from Fairfield Street to Bayview Boulevard. These blocks and lots were designed to accommodate commercial development of that age. The lots were platted at twenty-five foot widths with service alleys bisecting the lots in

both north/south and east/west directions. Such a design pattern is indicative of individually owned, attached storefronts with no setback from the street and extensive use of on-street parking. Servicing the businesses (loading/unloading, trash removal, etc.) was accomplished by use of the alleys.

Such a design pattern is faulty and inadequate under today's development standards. Under current development standards this design does not accommodate off-street parking, stormwater management, and landscaping requirements. Further, property is not typically developed as individual, twenty-five foot attached structures today. Typical business structure development is as a single structure divided into individually leased store fronts. To be properly developed, unified ownership of the property and re-plating is necessary. If there are multiple ownerships such land assemblage may prove difficult.

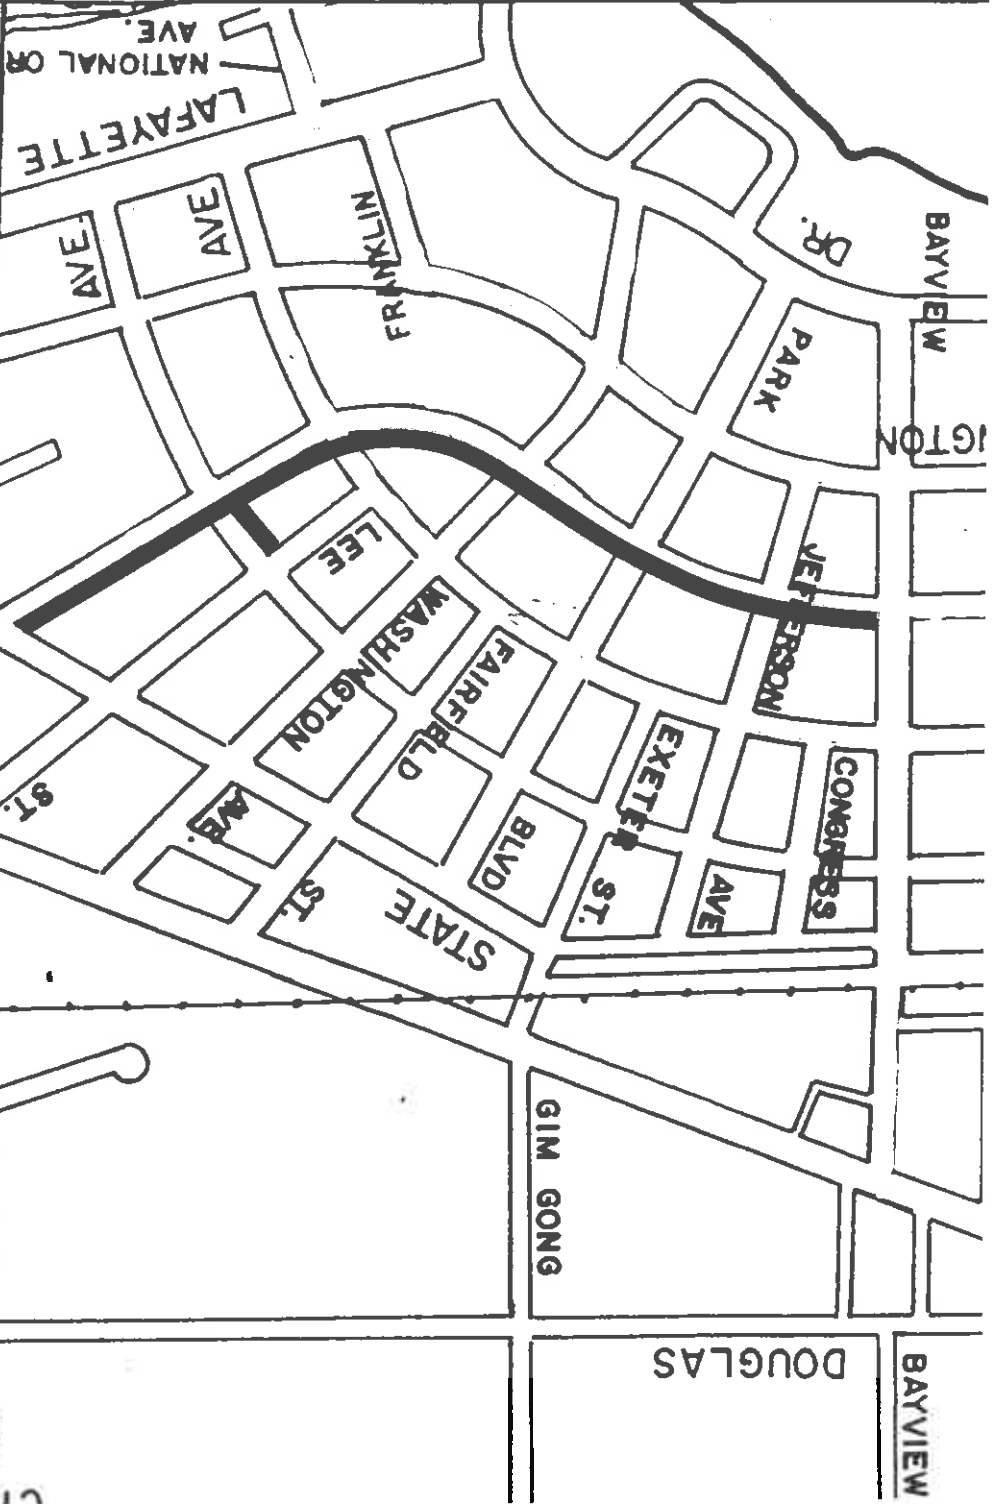
CITY OF OLDSMAR  
Exhibit 7.  
Existing Steep-Sloped  
Drainage Ditch System  
Community Development Department

Generally, there are no unsanitary or unsafe conditions present within the redevelopment area. The presence of some steep-graded drainage ditches, however, may constitute an unsafe condition. This is especially true along a portion of Dartmouth Avenue, south of the Methodist Church and along St. Petersburg Drive.
